Progress Report

Facility: Musselburgh Grammar

Roof Section: Roofs

Title
3rd Inspection

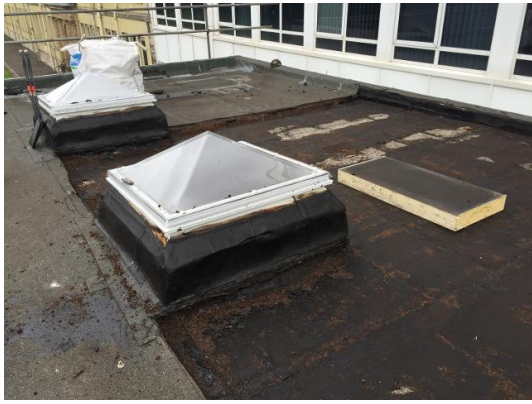
Photo 1

Works are progressing on the gym hall roofs, roughly 300m² of roof area has been stripped off, with vapour barrier, insulation and underlay installed.

Roof area being stripped on gym hall roof.

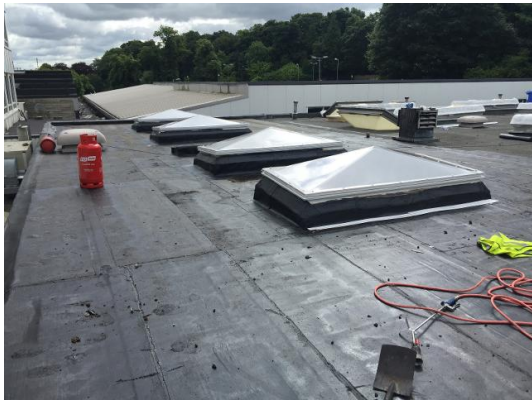
Photo 2

Area of roof showing vapour barrier, insulation and underlay installed.

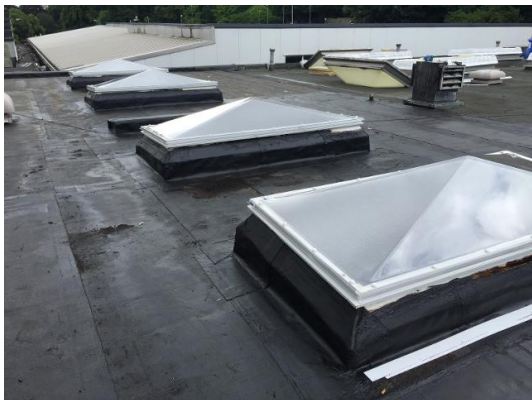
Photo 3

All rooflights are now on site and 10 new rooflights have been installed.

Old rooflights have been removed and disposed, new polycarbonate rooflights installed.

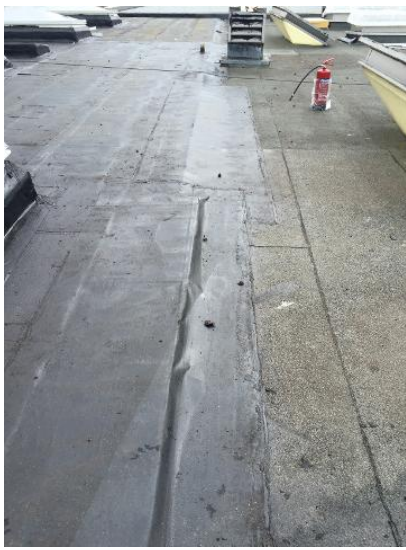
Photo 4

Night seal formed between new and old roof.

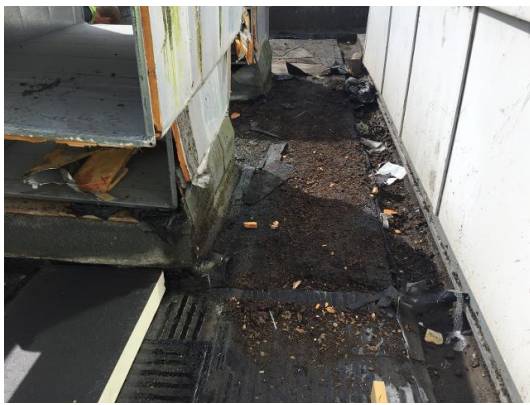
Photo 5

The low level roof above the music department is now a high priority for completion so that FES operatives can install the plant equipment and ducting before the schools are back. Roughly 120m² has been stripped on this roof.

Low level roof being stripped off.

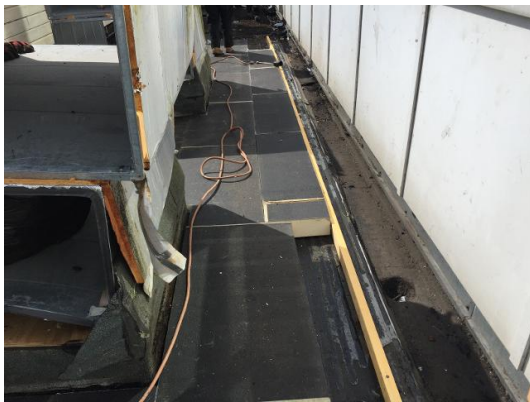
Photo 6

The aluminium cladding has been cut back by an other contractor so the operatives can install the new gutter detail.

Insulation being installed and new gutter detail formed at cladding.

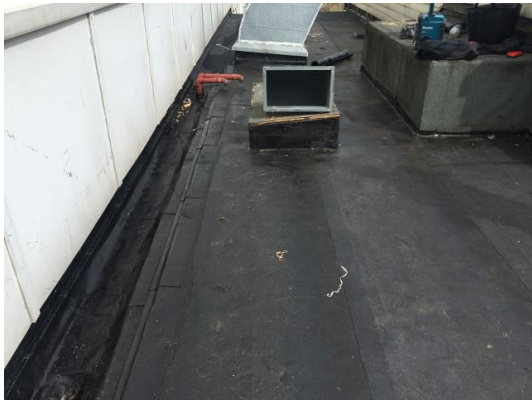
Photo 7

Underlay installed to insulation.

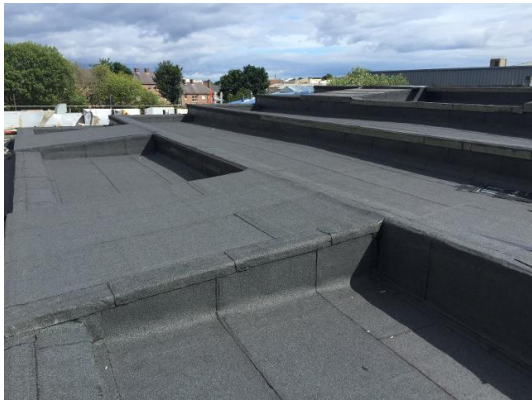
Photo 8

The assembly hall roof is now near completion, the operatives are finishing off the welded drip detail on the perimeter flashings.

Assembly hall roof is near completion.

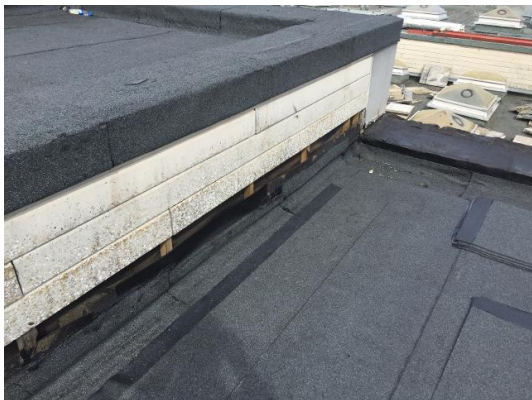
Photo 9

Wetted drips have been formed at roof perimeter.
